# Residual Debris Within Internal Features of As-Received New Dental Implants

*Purpose:* To investigate residual debris within internal features of new "as received" dental implants. *Materials and Methods:* A total of 15 new dental implants representing various dental implant brands were obtained in sealed containers from the manufacturers. Batch numbers and implant types were documented. In a controlled setting, implants were carefully unpacked, and their internal aspects were visually examined. Further analysis involved light microscopy imaging to document and photograph any foreign material. The internal aspect of the implants were sampled with both an endodontic paper cone and a fine bristle brush swab. These were inserted into the implant, rotated three times, then removed and examined under a microscope at 30× magnification. After sampling, some of the brushes and swabs were washed with alcohol to remove debris that could be further examined under magnification. *Results:* Inspection of the implants without magnification revealed no visible foreign materials. However, under light microscopy (10× and 30×), all 15 implants exhibited small black particles at various internal s

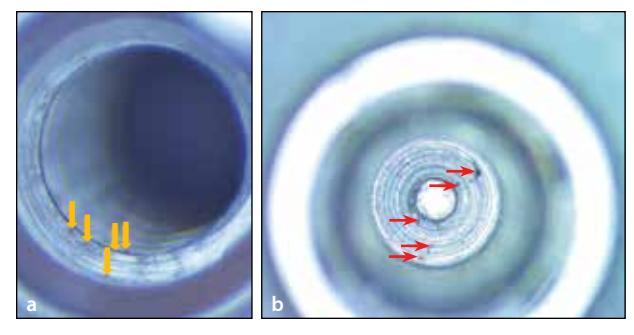
No material could be visually seen within the implant internal connection on any of the implants evaluated. However, under magnification, all 15 implants inspected contained material (primarily black spots) located within the base of the connection channel, at the top of the screw threads, and at the base of the screw shaft (Fig 1). Four implants had shards that were believed to be metal machining swarf on the connection surface (Fig 2a), and eight had material visible in the screw thread of the implant (Fig 2b).

**Fig 1** Photographs inside two different implants under magnification. Black spots are highlighted with *arrows. (a)* Abutment connection site. *(b)* Base of the screw channel.

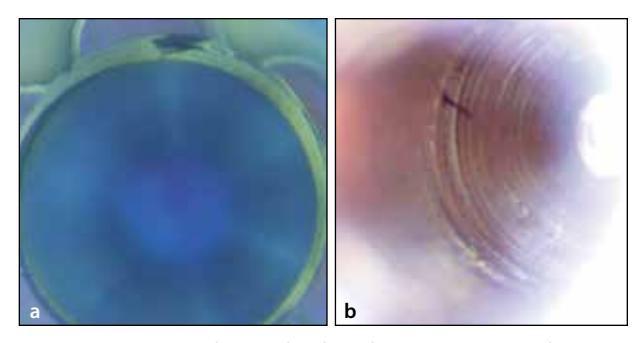
Fig 2 (a) Larger machining shard inside connection site. (b) Representative sample of debris within implant screw thread.

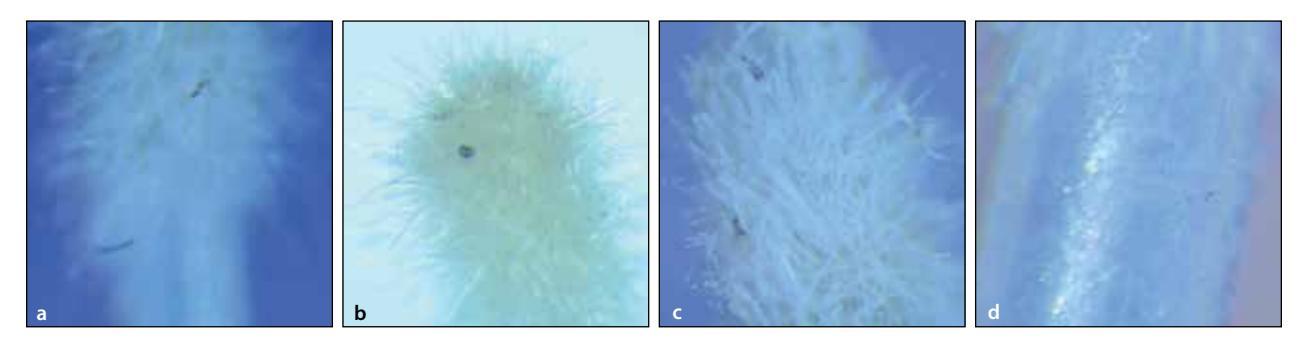
Figure 3a shows an example of the brush after insertion into the implant screw channel with metal shards clearly visible, and Figs 3b to 3d show more examples of metal particles trapped in the bristles and on the brush

Fig 3 The representative samples show (a) multiple shards of Ti in the brush, (b and c) particles in the brush, and (d) particles on the shank of the brush.

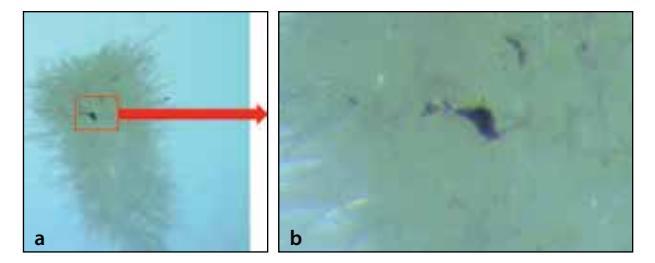
**Fig 4** (a) Brush image and (b) magnified image of *red highlighted area* showing Ti fragments.

shank. Figure 4 shows a higher-magnification view of one of these Ti particles picked up from the inside of an implant. Finer particles were also noted at the abutment connection sites coronal to the screw thread, which were readily picked up on the paper points (Fig 5). All 15 samples yielded foreign material when swabbed, which was assumed to be Ti particles and machine shavings. The particle size was estimated to be approximately 2 mm for larger shards (Figs 6 and 7a) and around 20 to 30 µm for smaller particles that could be detected (Figs 7b and 7c). One of the implants was subject to scanning electron microscopy (SEM) evaluation (Fig 8), which clearly showed material in the screw threads. Elemental diffraction spectroscopy was used to identify the particles involved, which were determined to be Ti galling particles (see Fig 8).

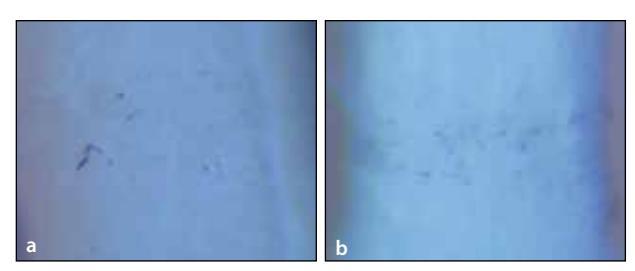
Fig 5 (a and b) Fine metal particles picked up on paper points in the connection site of a new implant.

Although various mechanisms have been proposed to cause Ti release, internal machining debris has not been considered. Recommended methods for debris removal include the use of paper points and directed suction into the implant interior, with novel cleaning devices under development for trapping and removing metal particles.<sup>29</sup>

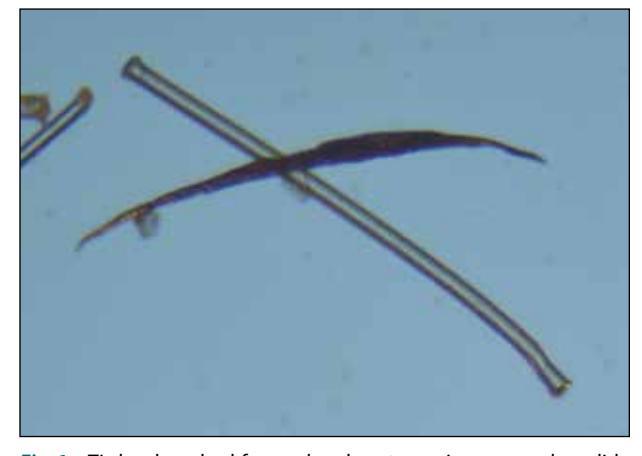
**Fig 6** Ti shard washed from a brush onto a microscope glass slide showing a size comparison to the 2-mm-long brush bristles *(clear rod)*.

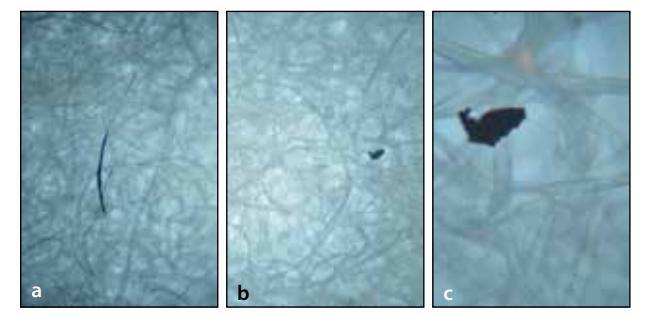
**Fig 7** Ti remnants washed onto 5- $\mu$ m filter paper at (*a and b*) 10× magnification and (*c*) 30× magnification.

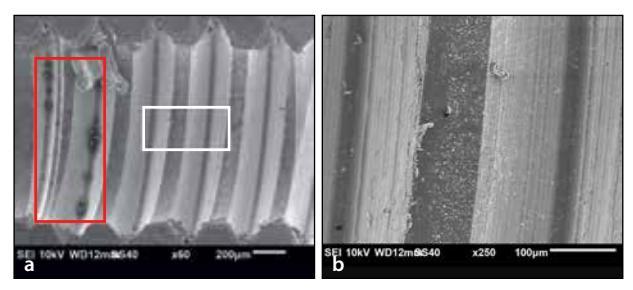
**Fig 8** (*a*) SEM of a new sectioned implant with larger particles clearly present in threads (*highlighted red*). (*b*) Inset of *white box* in part *a* at 250× magnification.
