Int Poster J Dent Oral Med 2007, Vol 09 No 04, Poster 385

## In-vitro study on bond strength of various intraoral ceramic repair kits used with different all-ceramic systems

2007 March 21-24  
85th General Session & Exhibition of the IADR, 36th Meeting of the CADR  
New Orleans USA

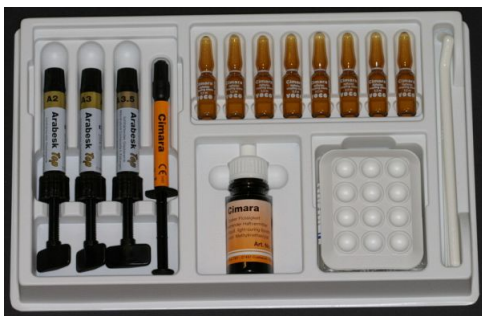
Fig.1a Ceramic repair system: Cimara (Voco) Fig.1b Ceramic repair system: Silistor (Heraeus Kulzer)

Four intraoral ceramic repair systems (Fig 1) : a) Cimara (Voco), b) Silistor (Heraeus Kulzer), c) Ceramic Repair (Ivoclar Vivadent), d) CoJet-System (3M Espe) were applied on four different all-ceramic systems: IPS Empress 2 (Ivoclar Vivadent), Vita In-Ceram Alumina Blank, Vita In-Ceram Alumina slickered (Vita Zahnfabrik) and Cercon (Degudent). The specimens (10□10□3mm) were divided into substructure and veneering porcelain and were prepared with the repair material with a silicon form (Ø5□3mm) following the guidelines for an intraoral repair (Fig. 2). After 24 hours of storage in artificial saliva (37° C), the prepared specimens were debonded using a shear bond strength test in a universal-testing-device (Zwick) with a crosshead-speed of 0.5mm/min until fracture (n=10) (Fig. 3). Fracture modes were examined visually and in some cases microscopally and divided into adhesive, cohesive, and combined fractures. Results were statistically analyzed (ANOVA, Duncan's,  $p < 0.05$ ).

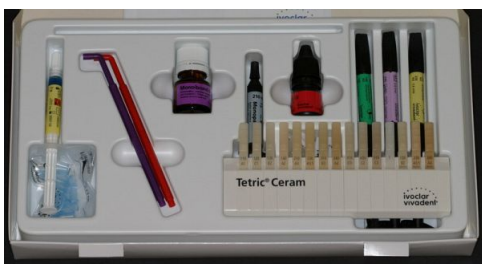
Fig.1c Ceramic repair system: Ceramic Repair (Ivoclar Vivadent)

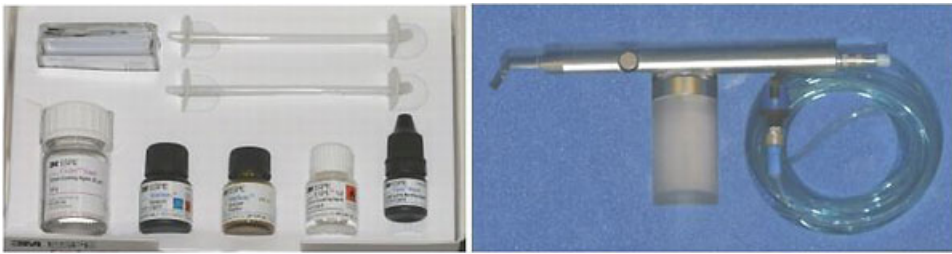
Fig.1d Ceramic repair system: CoJet-System (3M Espe)
