Migration of a Dental Implant into the Maxillary Sinus: Case Report.

Rodrigues P*, Afonso C. **, Caetano A. **, Nathalal D. **, Silva V. **
* Implantology Consultation I.S.C.S.E.M.
** Volunteers Implantology consultation I.S.C.S.E.M.

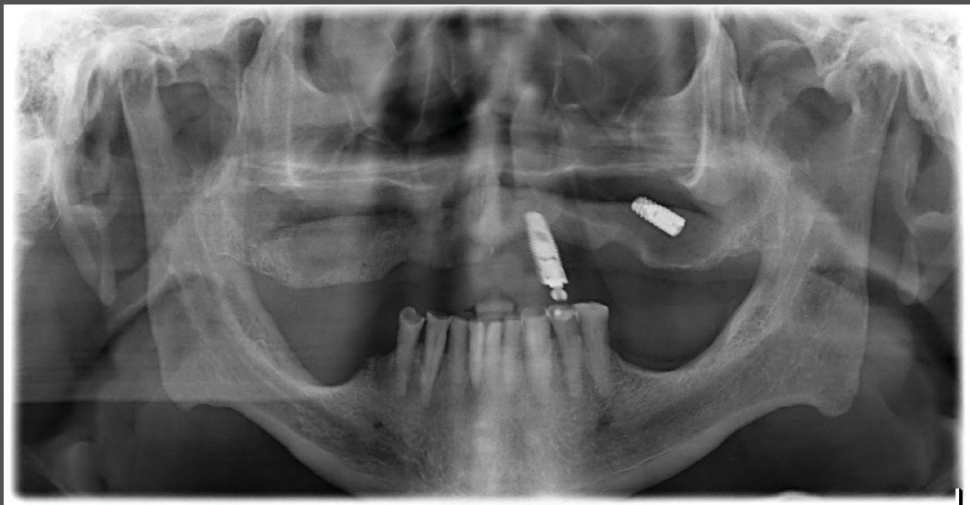
Image 1 - Initial Ortopantomography

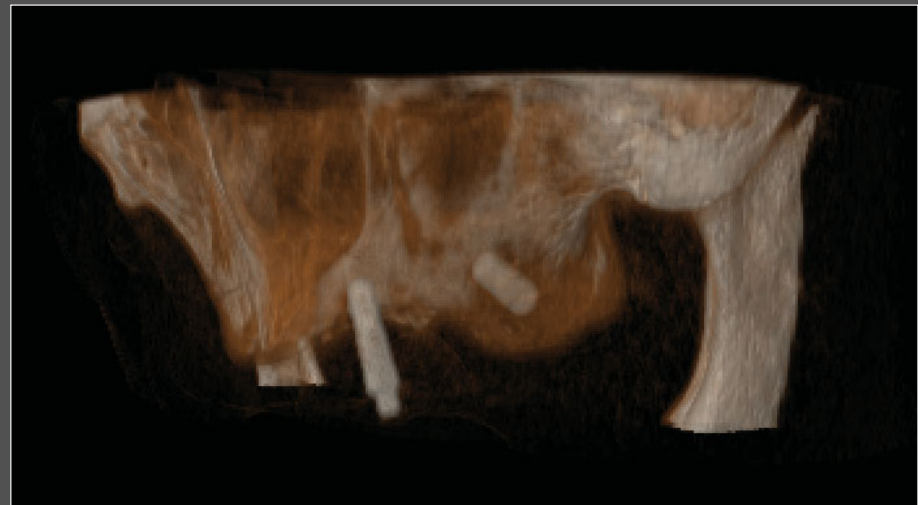
Image 2 - 3D Reconstruction of CT scan

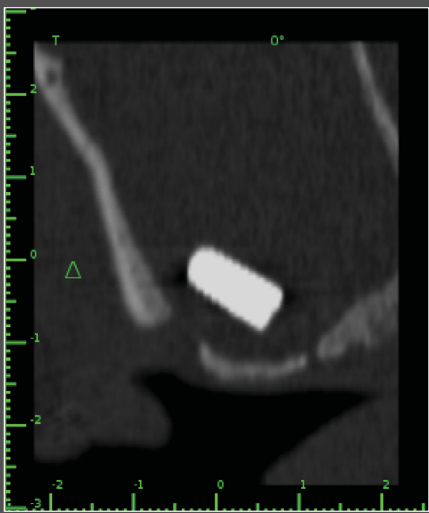
Image 3 - Oroantral Fistula

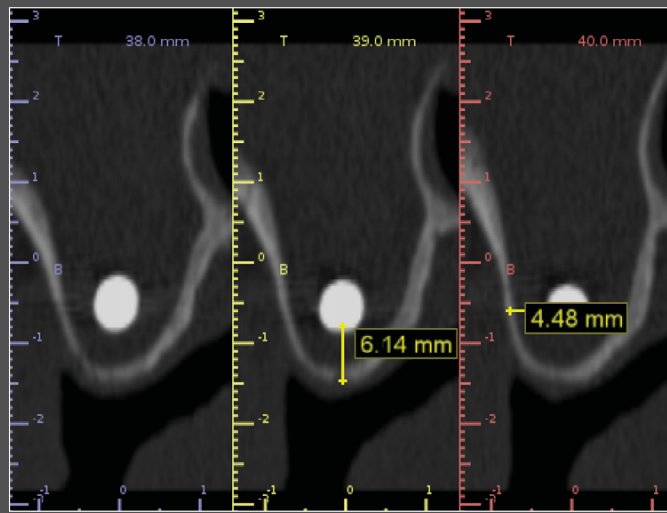
Image 4 - Location of the implant on the CT scan

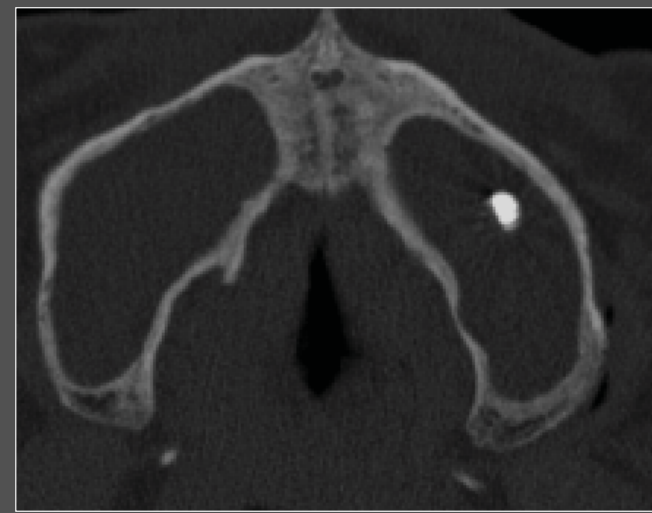
Image 5 - Location of the implant on the CT scan

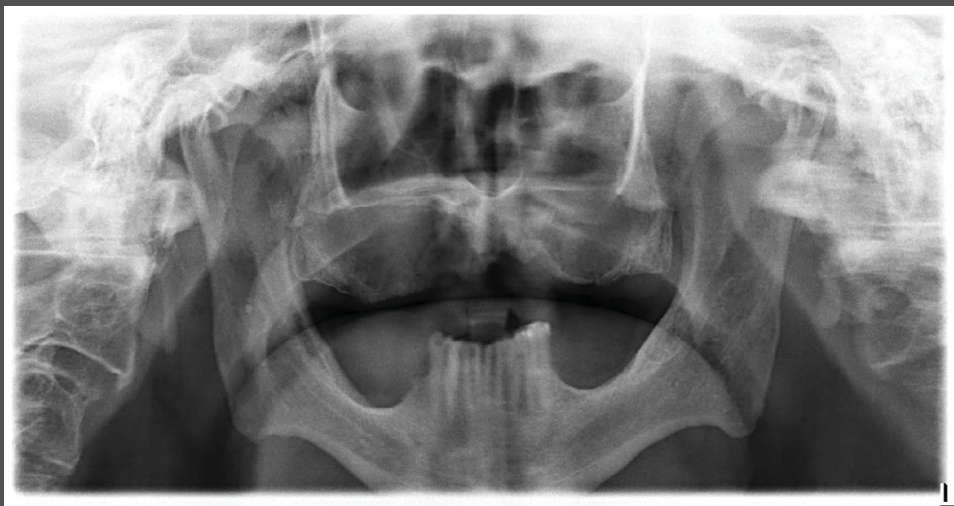
Image 12 - Final Ortopantomography
