Functional Aesthetic Rehabilitation of a Patient with Dental Biocorrosion: A Case Report

The main goal of this report was to solve a clinical case of a 73-year-old man with diabetes, partial edentulism and a pathological occlusion with biocorrosion using conservative and adhesive techniques. A complete rehabilitative treatment was performed, increasing the vertical dimension of occlusion using indirect restorations with composite resins on teeth and resin crowns on implants and returning function using mutually protected occlusion. A 6-month posttreatment clinical and radiographic follow-up was performed.

Chin J Dent Res 2020;23(3):215–220; doi: 10.3290/j.cjdr.a45226

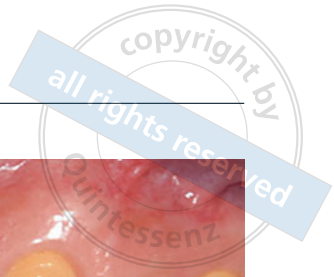
At the intraoral clinical examination, the absence of teeth 35, 36 and 37 was observed, with a reduction of mucogingival tissue in a horizontal direction, generalised severe dental wear and gingival recession (Fig 1). At the extraoral examination, a slight loss of facial contour was observed and the smile analysis presented a reverse incisal occlusal plane with a low smile line.

Fig 1a and b Intraoral clinical examination.

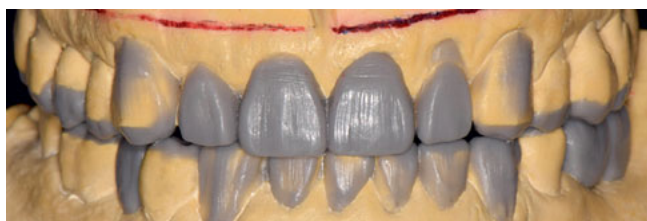
Complementary examinations were carried out, such as study models, photographs, radiographs, tomographies, diagnostic wax-up and glycosylated haemoglobin examination, obtaining a diagnosis of pathological occlusion associated with dental wear due to biocorrosion with VDO loss. An aesthetic jig (Pattern Resin LS, GC America, Alsip, IL, USA) was made in the central incisor with the purpose of developing a diagnostic wax-up, restoring an ideal occlusion plane with an increase in the VDO and simulating two restorations on two implants in the edentulous zone (Fig 2).

Fig 2 Diagnostic wax-up with a new VDO and levelling of the occlusal plane.

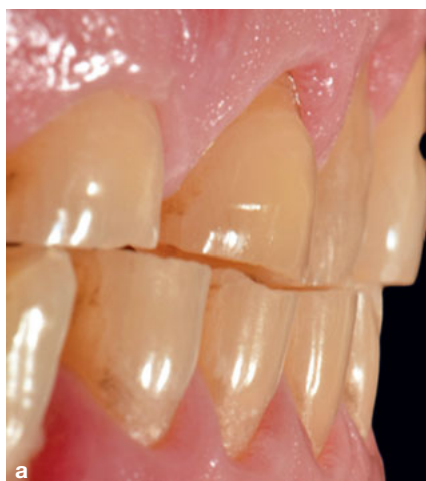
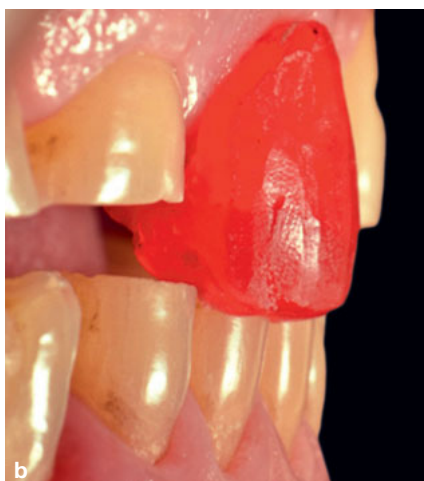
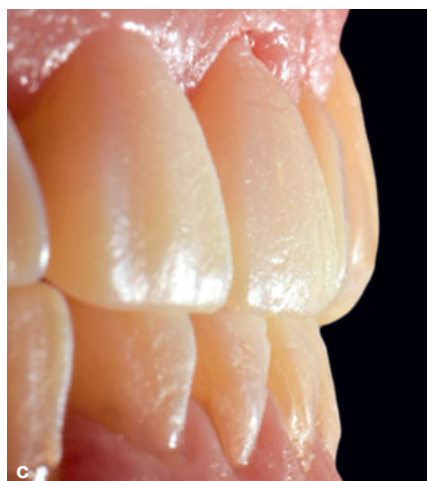
Fig 3 (a) Initial VDO at the incisal level. **(b)** New VDO with the multifunctional jig. **(c)** VDO determined by the provisionals.

was evaluated for 3 weeks with provisionals, resulting in good patient acceptance (Fig 3). The hygiene phase was carried out, comprising dental prophylaxis and physiotherapy.

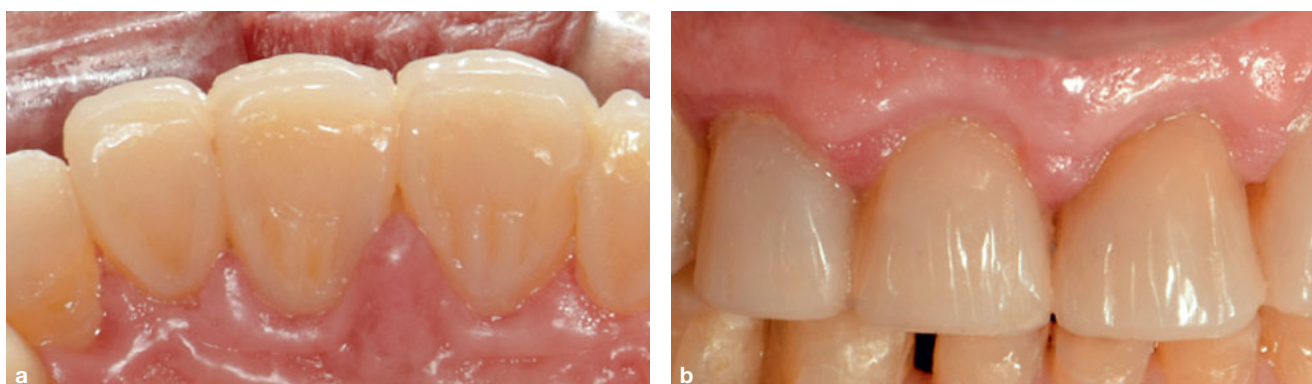
The suggested treatment was the sandwich technique, which consists of the minimum preparation of the palatal surface for the fabrication of palatal veneers so that the tooth is finally complemented with veneers. In this case, the sandwich technique was used with indirect palatal veneers and direct veneers on teeth 12, 11, 21 and 22 (Fig 7).

Fig 7 Modification of the sandwich technique on teeth 12, 11, 21 and 22. (a) Indirect palatal veneers. (b) Direct restorations.

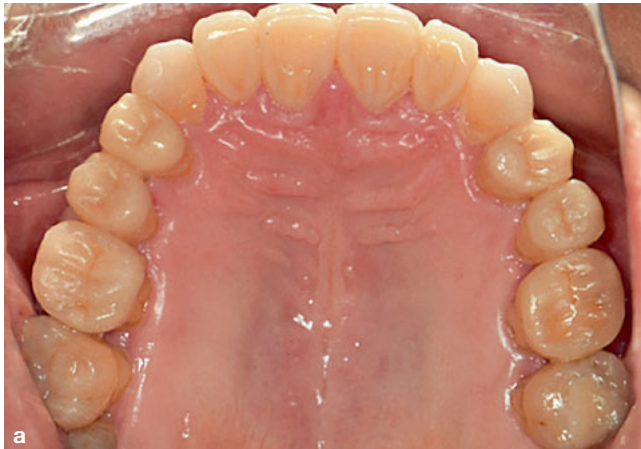
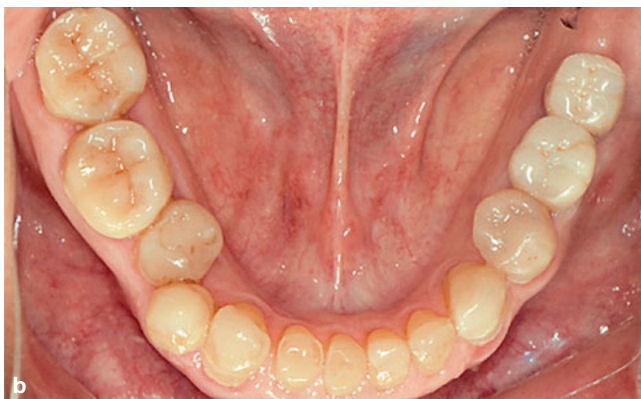
Fig 9a and b Posttreatment clinical occlusal photographs after 6 months of function.
