Int Poster J Dent Oral Med 2008, Vol 10 No 04, Poster 426

Dental Alloys structural analyses of welded frameworks

DENTAL ALLOYS STRUCTURAL ANALYSES OF WELDED FRAMEWORKS

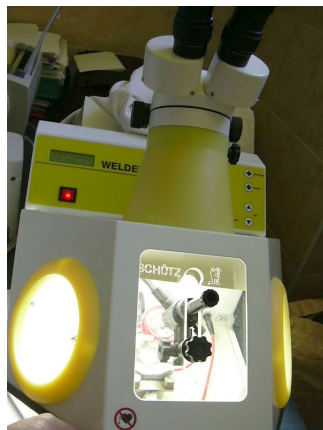
Fig. 1b: Welding equipments:
microimpulse Welder.

Radiographic, metallographic and microhardness analyses were made in order to certify welding quality, casting alloys structural defects, to stand out possible the cracks within the base material. The welding parameters used for laser welding were: P med(W): max.120; Pp(KW) max. 5; tp(ms) 0,3-20; f max (Hz) 600; Ep (J) 0,1-50 and for microimpulse were: power - level 4, overlapping more than 1/2, time delay 40 milliseconds, one side welding.

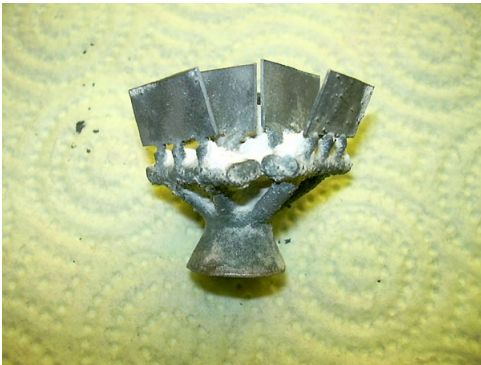
Fig. 2a: Different welding types: Cast plates

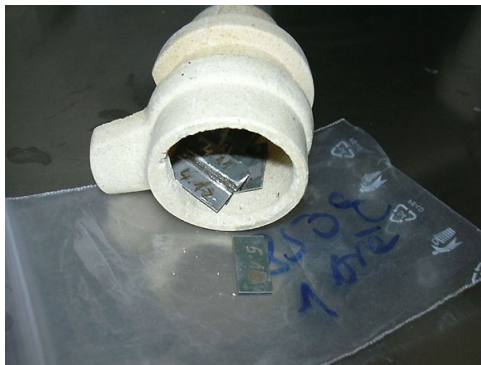
Fig. 3a: Heat treatments for dental alloys: Preparing for heat treatment

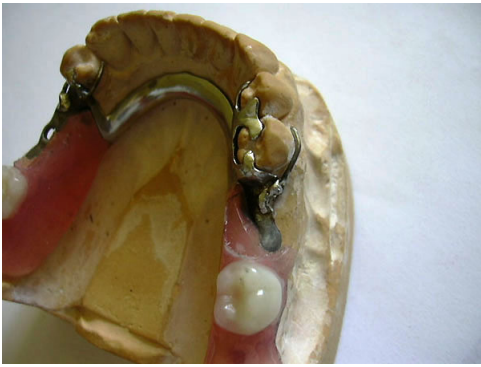
Fig. 4b: Welding of RPD framework: Welded Mc Cracken clasp

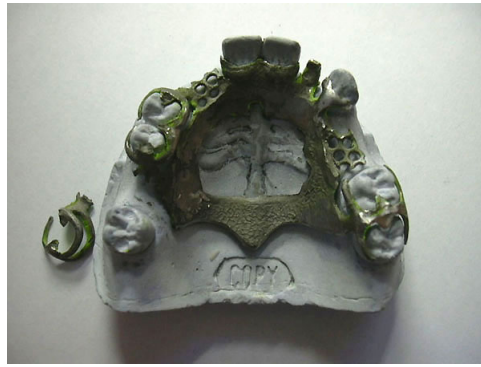
Fig. 4c: Welding of RPD framework: Crack of circumferential clasp

Noninvasive analyses methods point out casting alloys structural defects, distinguish the cracks within the base material. The cracks appear mostly in base material, being caused by casting, non-adequat processing and rapid cooling of weld. Structural analyses present dendritic structure specific for cast alloys, non-metallic inclusions and some temporary particles. Intergranular pellicular precipitations and spherical shape compounds placed inside the crystalline grains appear on some welding. Welded area alloys chemical composition discreetly differs from the base material.

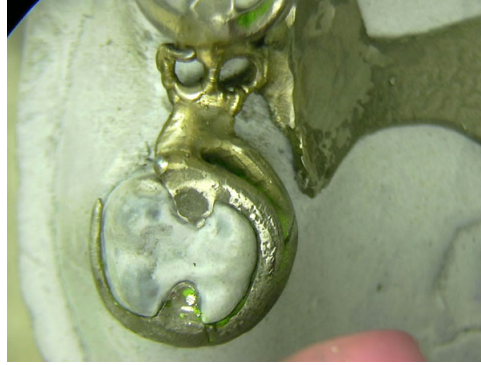
Fig. 4e: Welding of RPD framework: Detail of welded clasp

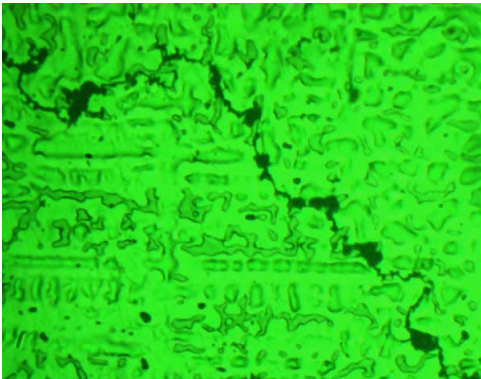
Fig. 6i: Metallographic aspects: Base metal

Fig. 6j: Metallographic aspects: Base metal

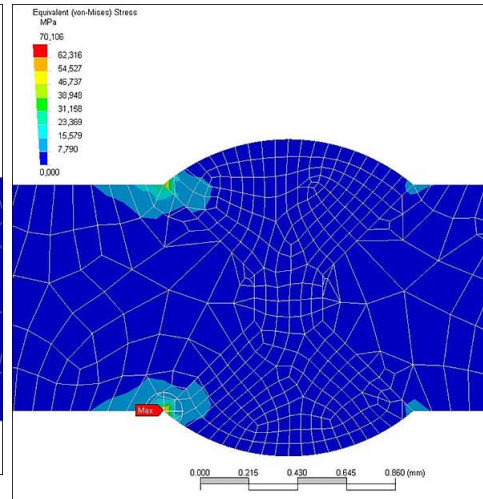
Fig. 7c: Numeric analyses of welding: Stress
distribution in alloy

Fig. 7d: Numeric analyses of welding: Stress
distribution 2

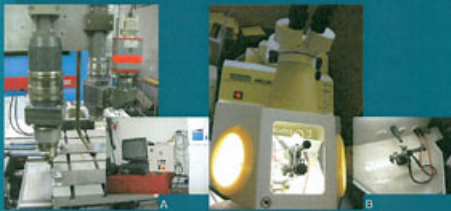
Fig. 1. Welding equipments: A. Nd:YAG laser - HL 124P LCU TRUMPF; B. micropulse Welder.
